AFRL-ML-WP-TR-2000-4099

**ADVANCED THERMAL BARRIER
COATING**

DR. RABI S. BHATTACHARYA

FINAL REPORT FOR 05/03/1999 – 02/03/2000

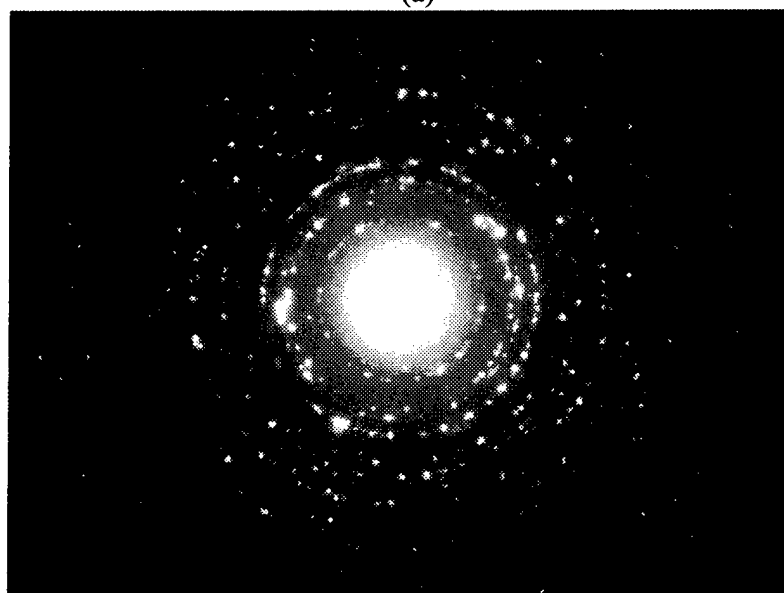
Figure 17. (a) Dark field and (b) diffraction micrographs for sample 139Y. This sample was initially seeded with fine alpha alumina particles, then cathodically coated with alumina at 850°C, which was lower than the standard temperature of 950°C. Most of the rings correspond to alpha alumina, suggesting that the alumina seeds may have facilitated formation of alpha alumina at a lower temperature.

Figures 17a and 17b are dark-field micrograph and diffraction pattern for sample 139Y that was seeded with alpha-alumina particles, and then coated with alumina using the cathodic deposition technique. The coating was applied at 850°C. Recall that in unseeded samples, this temperature resulted in the formation of gamma alumina rather than alpha alumina. Most of the rings in Figure 17b, particularly the strong ones, correspond to that of alpha alumina. Dark field images at different diffraction conditions indicated that the alpha alumina phase covered almost the entire region of the sample; i.e., the surface coverage was much larger than the initial coverage of alpha-alumina powder determined by high magnification SEM (see Figure 17c). While these results do not fully confirm that alpha alumina seeding may be beneficial to alpha-alumina formation at a lower temperature, the results are encouraging. Future efforts will attempt to confirm if this methodology of seeding is indeed beneficial in lowering the temperature for alpha alumina deposition.
